**NOTICE OF VIOLATION: SITE INSPECTION OF THE YUBA SUTTER DISPOSAL INC.,  
LANDFILL, YUBA COUNTY**

## INSPECTION REPORT

LOCATION & COUNTY: Yuba Sutter Disposal, Inc., Yuba County

INSPECTION DATE: 29 June 2011

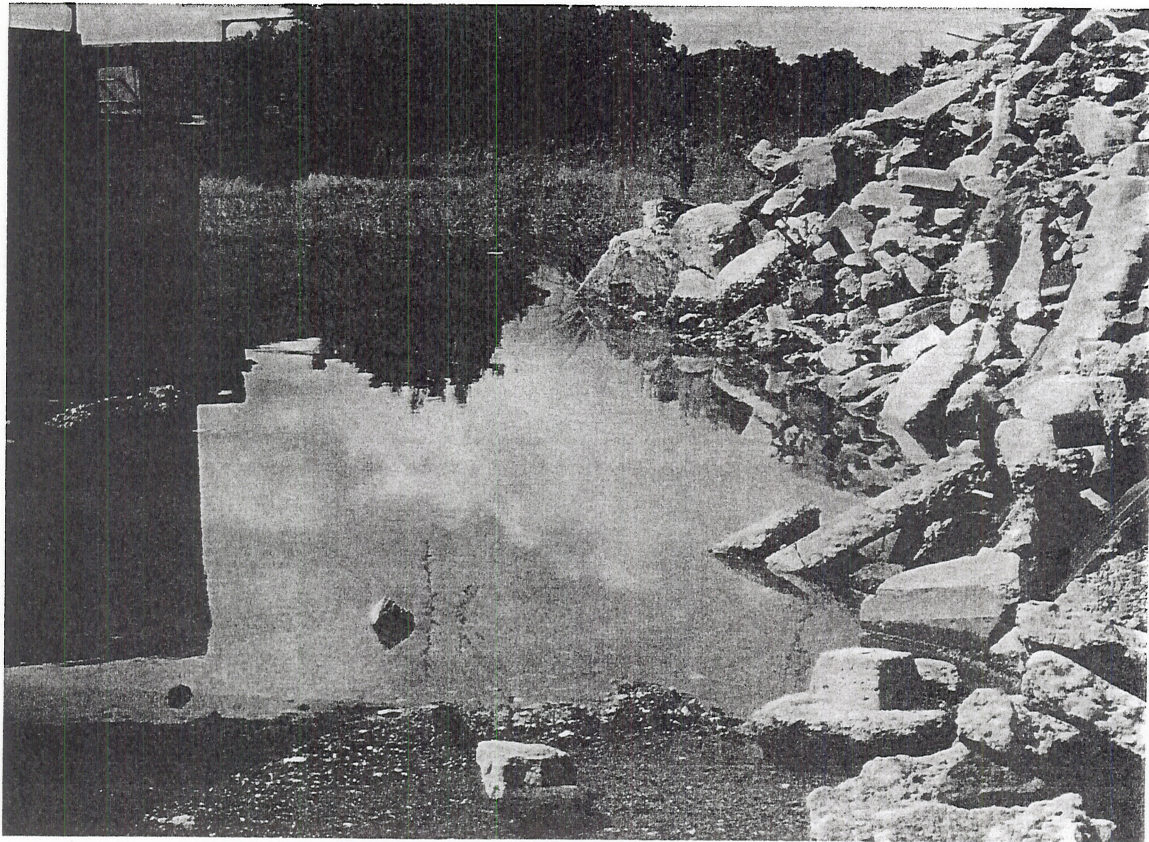
Staff inspected the southern area of LF-1, which is being used as a storage yard for debris bins, concrete rubble, white goods, dimensional lumber, and assorted scrap metal. An area of concern on LF-1 was the standing water observed. It is apparent that settlement of the waste mass has occurred thus allowing storm water to pond. Facility Specification, B.12 of WDR R5-2003-0093, states: *Closed landfill units shall be maintained to promote runoff and to prevent ponding.*

Photo 2: Standing water over LF-1 due to lack of drainage.

Based on observations made during this site visit, the facility uses WMU LF-1 as a storage yard for concrete rubble, debris boxes, scrap metal, white goods, and dimensional lumber. It was evident that drainage of WMU LF-1 has not been maintained and that settlement of the cover has occurred. To address Facility Specification B.12, staff is requesting the Discharger to submit a work plan by **15 September 2011** that restores drainage to WMU LF-1. The work plan should include a schedule of activities that will be performed during this construction season.

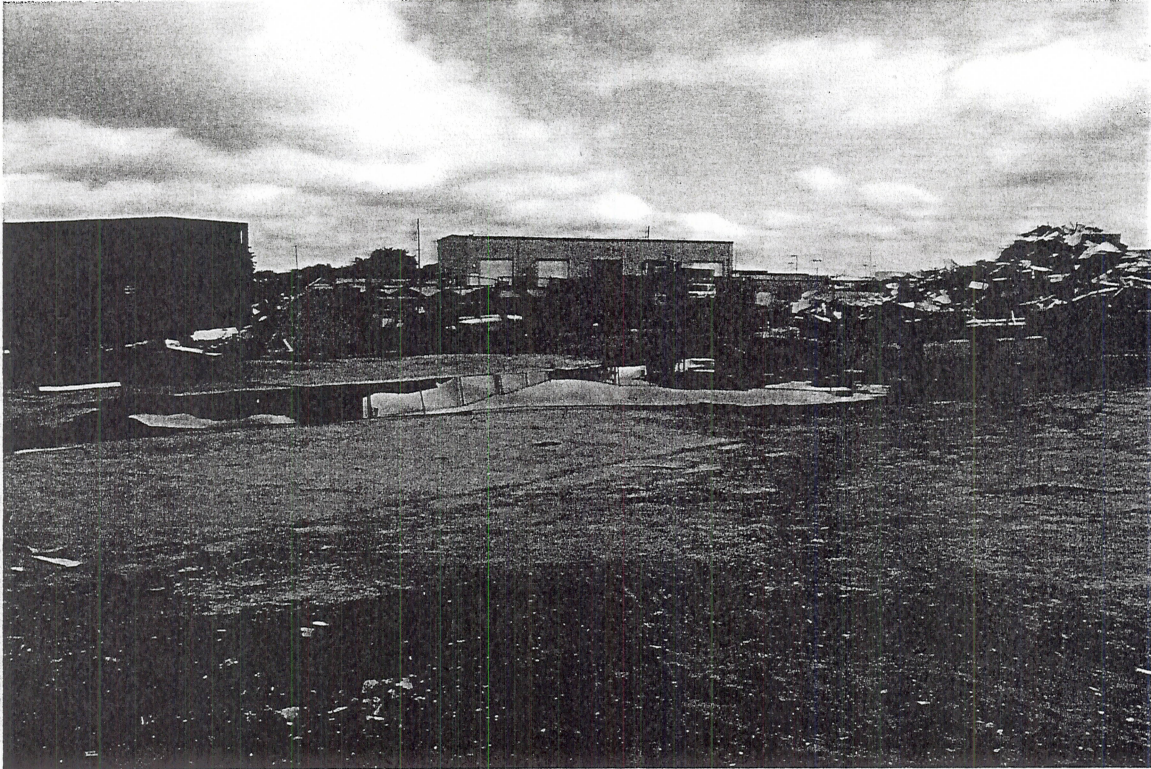
Photo 3: Standing water over LF-1. Note low spot due to settlement of waste mass.

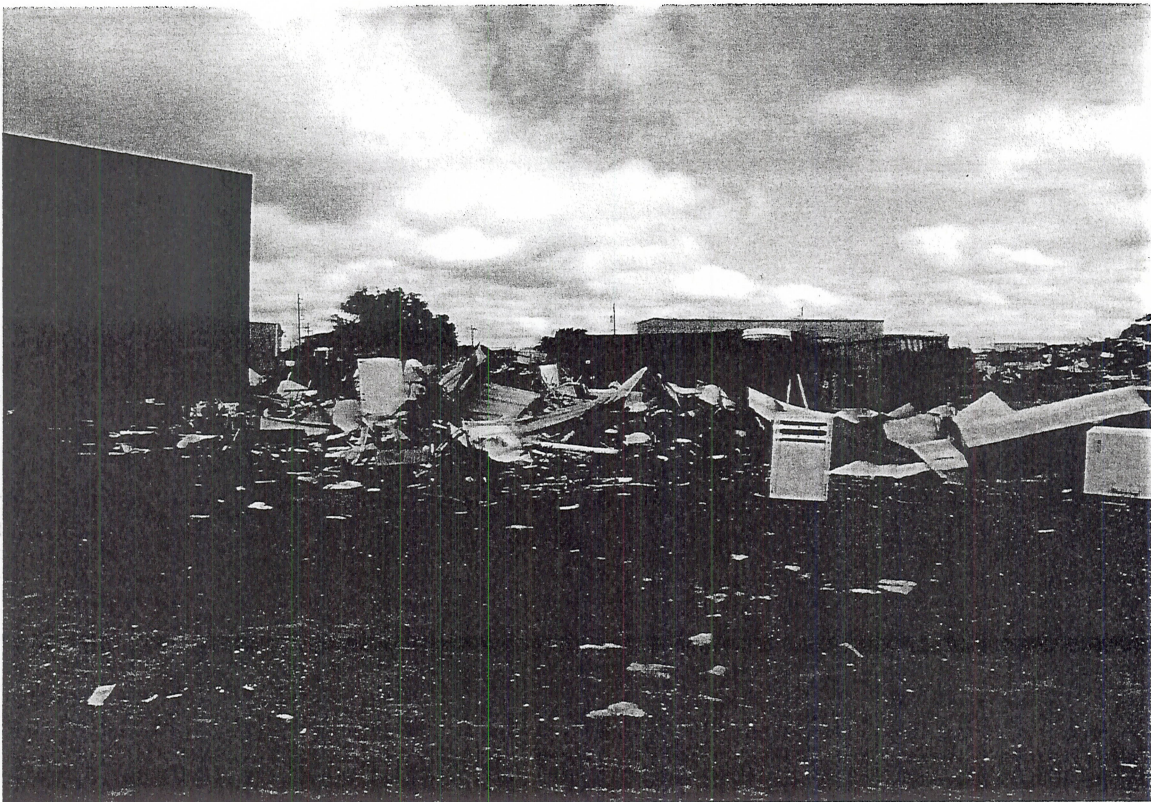
Photo 4: Scrap metal stockpiled over LF-1.

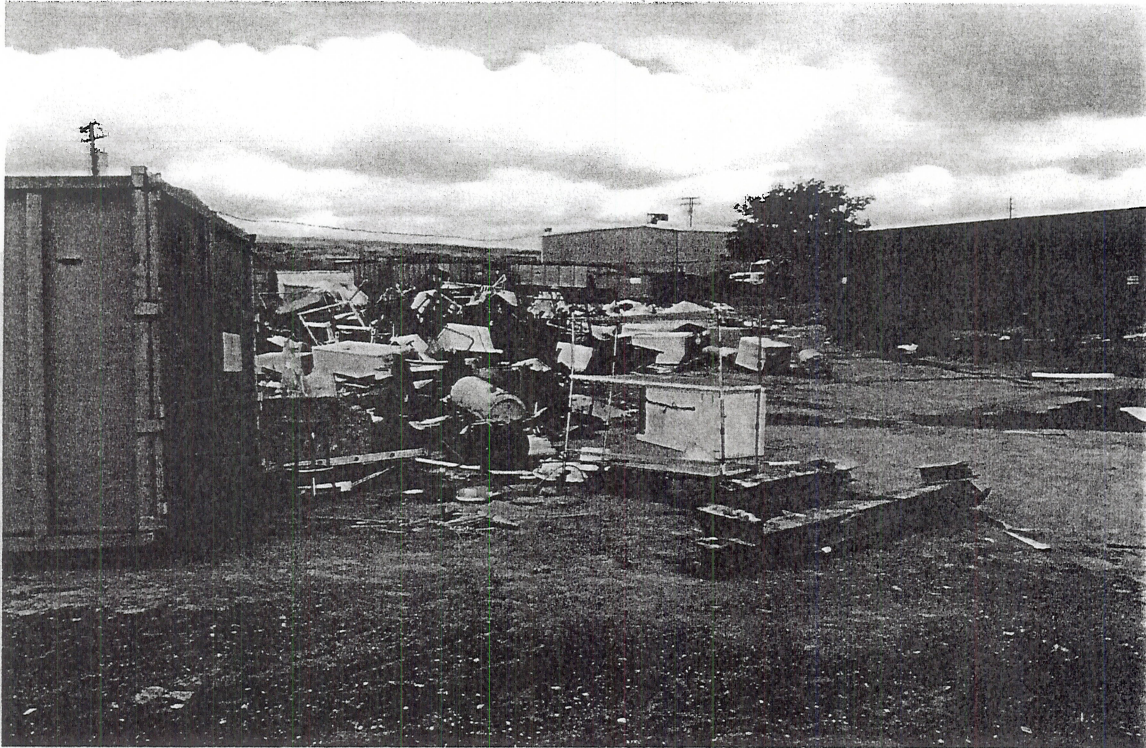
Photo 5: White goods storage over LF-1.

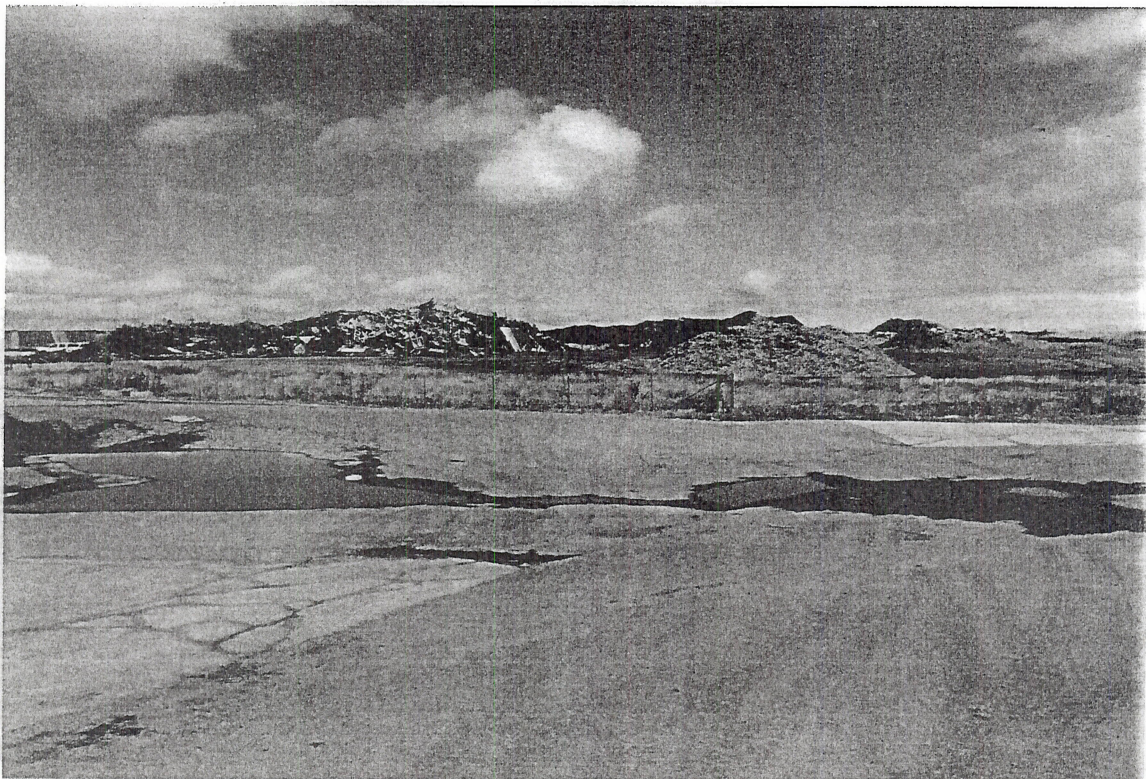
Staff inspected the north-northeastern area of LF-1 where the composting operation is located. As shown in the photographs settlement of the waste mass has created low spots that are collecting storm water. A portion of the surface area of this part of LF-1 is paved with asphalt for drive paths. Settlement and ponding is the main issue and area of concern. Composting is performed on a soil surface and leachate is ponding as shown in the photographs.

Photo 6: Low spots as a result of settlement. Note cracked concrete.

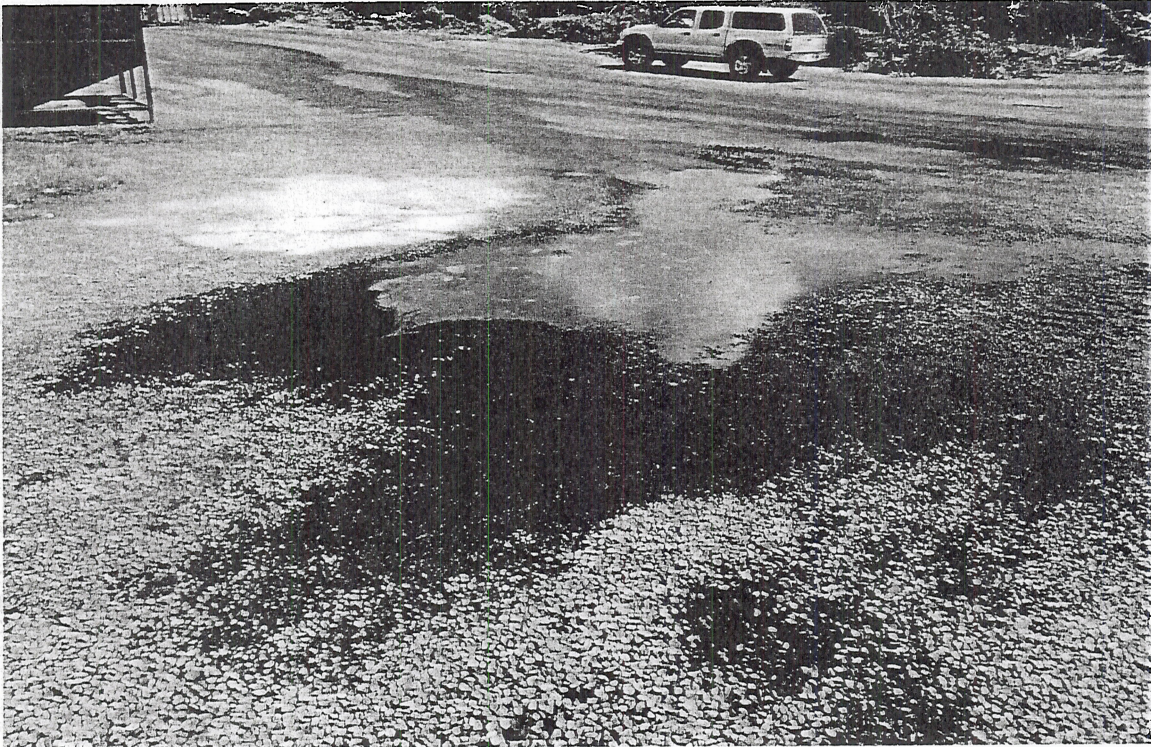
Photo 7: Leachate ponding from compost area. Note drainage from the upper left to this low spot on LF-1.

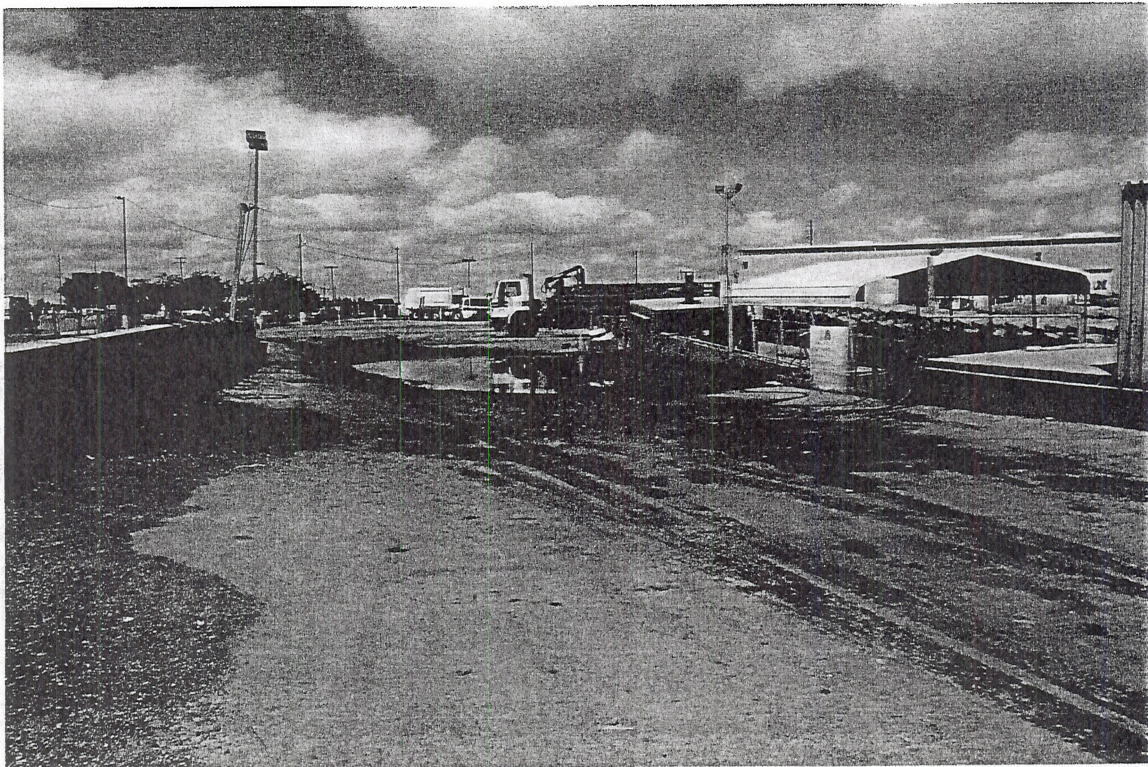
Photo 8: Standing water over low spot of LF-1.

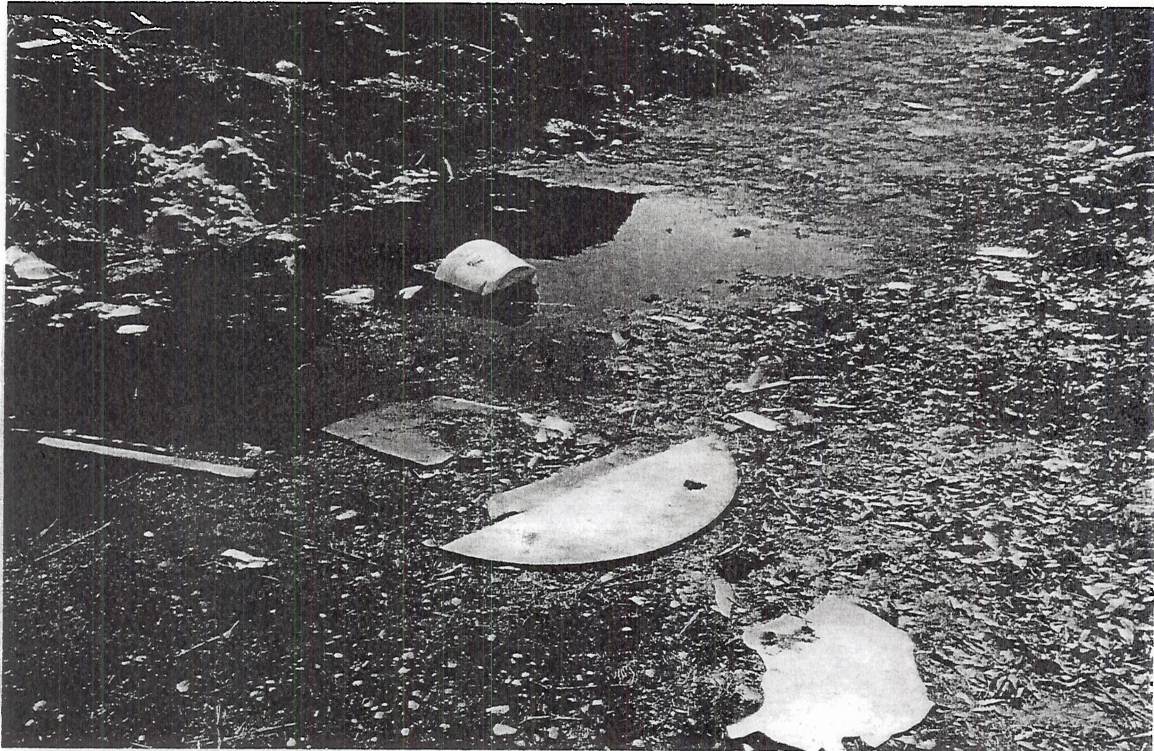
Photo 9: Leachate ponding at base of compost piles.

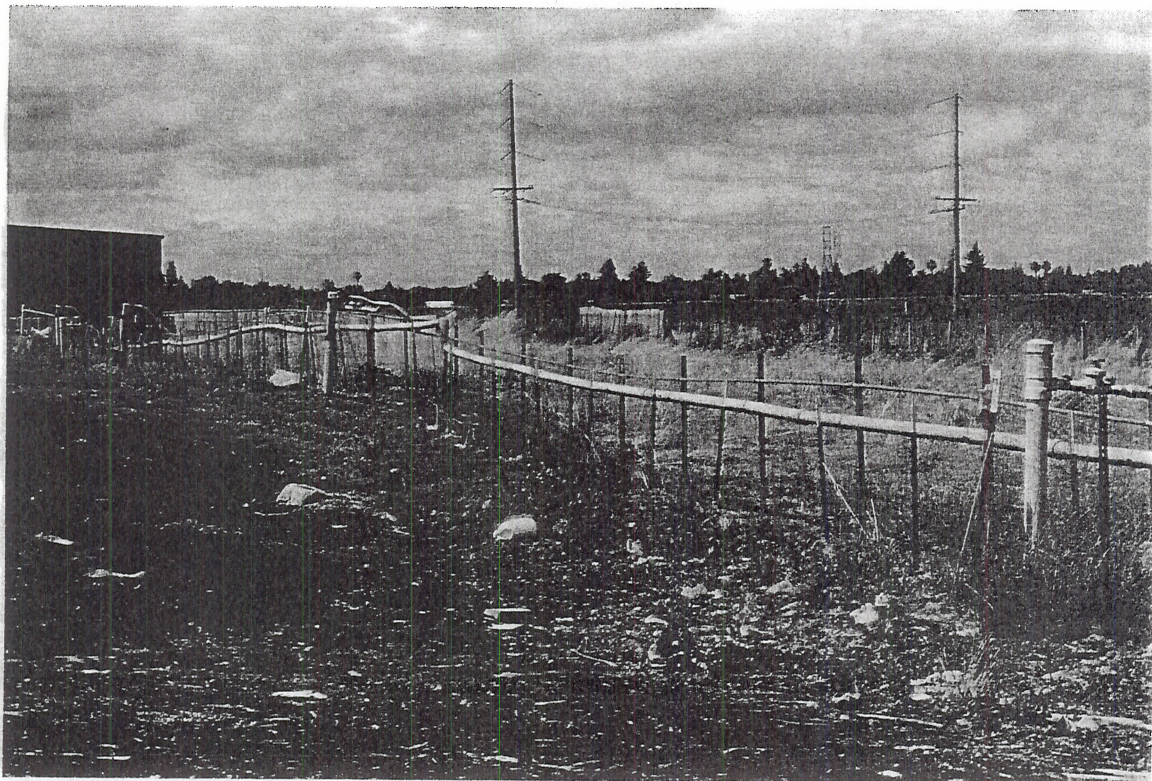
Photo 10: LF-1 northern site boundary with LFG extraction wells and header pipe.
